Fault Diagnosis and Maintenance of EX1 Switch in Volkswagen Magotan Lighting System

Study the lighting EX1 switch of the Volkswagen Magotan B8L model, analyze the switch control principle and composition structure. Through typical fault cases of EX1 switch LIN line and redundant line, analyze the fault phenomenon, carry out fault diagnosis, and complete fault maintenance.

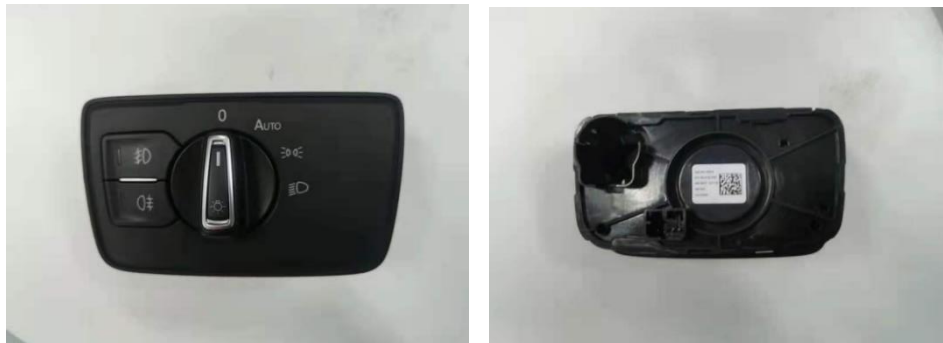
EX1 switch, also known as light rotary switch. The light rotary switch is installed below the dashboard on the left side of the steering column, as shown in Figure 1. The light rotary switch mainly consists of the following parts: the rotary switch; Rear fog lamp switch; Front fog lamp switch.

Fig.1 Composition of light rotary switch

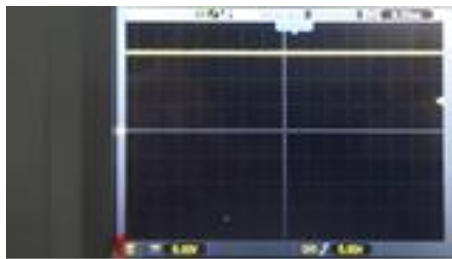
The second step is to test the redundant signal of the light switch at the J519 end. Turn on the ignition switch and first check whether the power supply and grounding of the EX1 switch are normal. If the power supply and grounding are normal, then use an oscilloscope to measure the ground waveform of the T73a/29 terminal of J519, as shown in Figure 3. The measured result is a 12V straight line, which is abnormal.

Fig.3 Ground Waveform of J519T73a/29 Terminal

Based on Step 2, it is preliminarily determined that T4di/4 of EX1 and T73a/29 of J519 are short circuited to the positive. Disconnect the negative terminal of the battery, check the continuity of the circuit, and obtain a resistance of 0.9 ohms from a point on the line to the positive terminal of the power supply. The result is that T4di/4 of EX1 and T73a/29 of J519 are short circuited to the positive. Finally, recover the fault, turn on the ignition switch to clear the fault code, operate EX1 again, and check if the fault still exists.

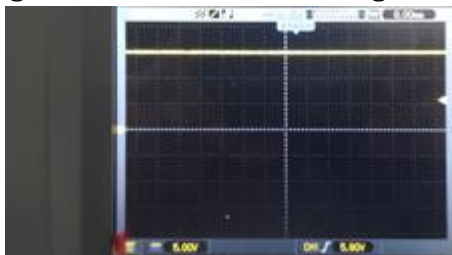
The third step is to test the redundant signal at the EX1 end. Turn on the ignition switch and use an oscilloscope to measure the ground waveform of the T4di/4 terminal of EX1. The measured result is shown in Figure 4, and it is a 12V straight line, which is abnormal.

Fig.4 Ground waveform diagram of EX1T4di/4 terminal
